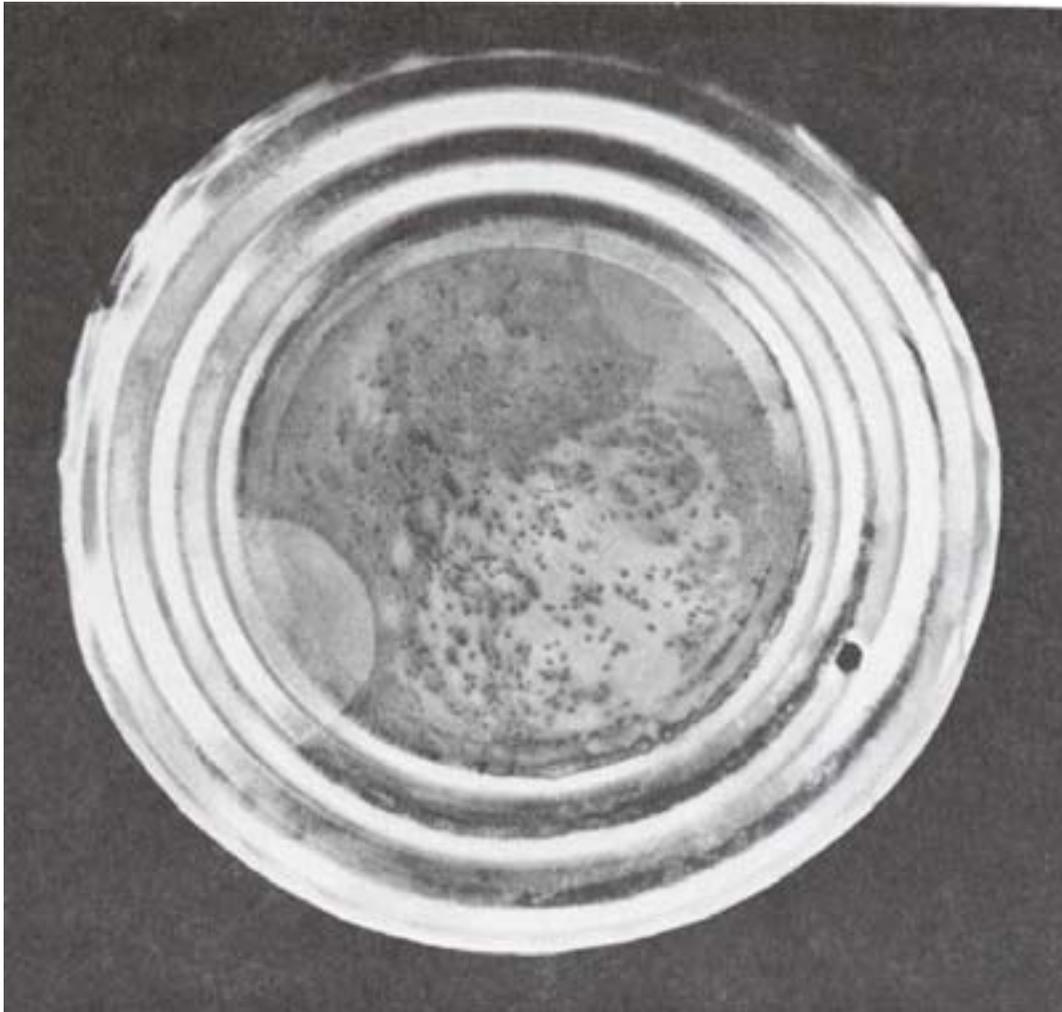
RUST

Table IV, Defect No. 109, Major defect. Pitted rust developed in retort basket.
