## OUTSIDE TINPLATE OR COATING (WHEN REQUIRED)

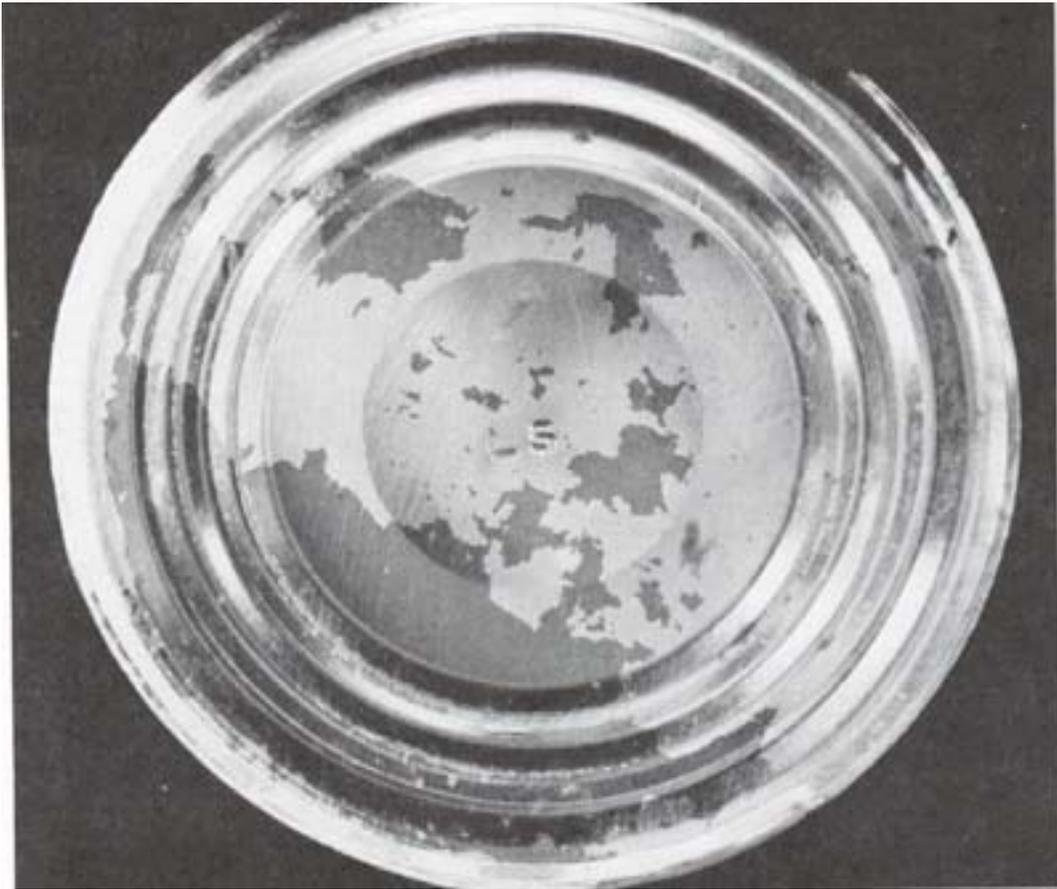
Table IV, Defect No. 203, Minor defect. Enamel missing - flaked.
